A Proposed Highly Damped Repair for the Aft Fuselage of the F/A-18

DSTO-TR-1374

Air Vehicles Division
Platforms Sciences Laboratory

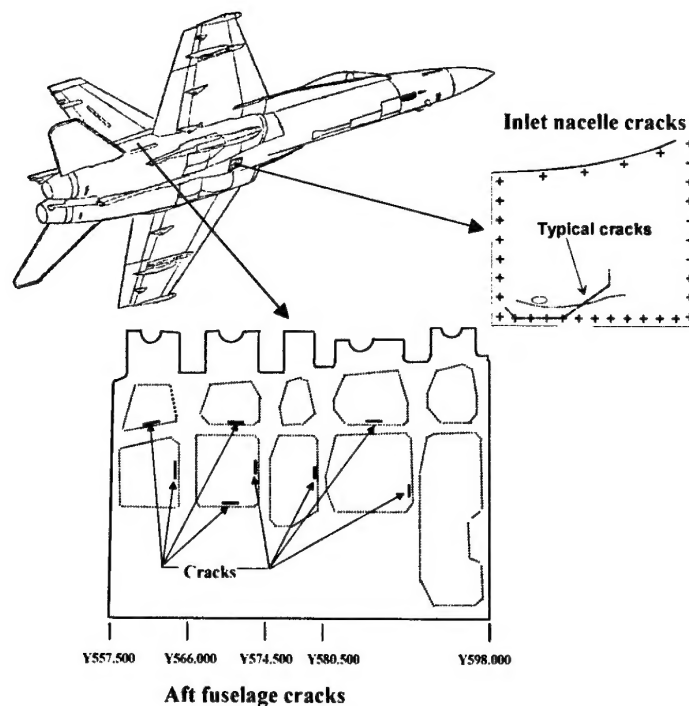
The chemically milled steps for panels in the aft fuselage are shown dotted in Fig. 1. Cracks occur in the chemically milled step region, and are generally parallel to and midway along the longest side. The aft fuselage section shown in Fig. 1 contains a composite of all known crack locations and occurs between fuselage stations Y557.500 and Y598.000. The conventional repair involves removal of the crack and use of a metallic doubler attached by mechanical fasteners. To carry out this type of repair the engine needs to be removed.

Figure 1. Acoustic fatigue cracking on the F/A-18
